BURGESS INSPECTION GROUP, INC.

PROPERTY INSPECTION REPORT

Concerning: 123 Anywhere Lane, McKinney TX 75071
(Address or Other Identification of Inspected Property)

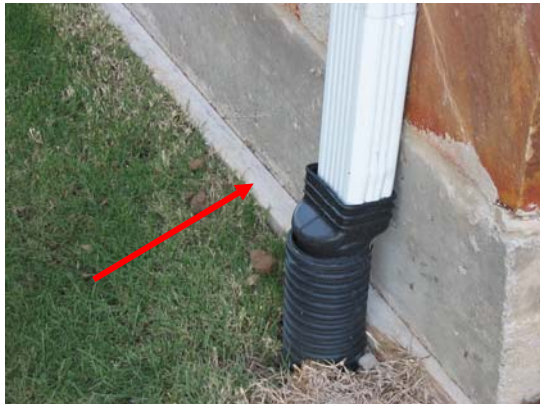
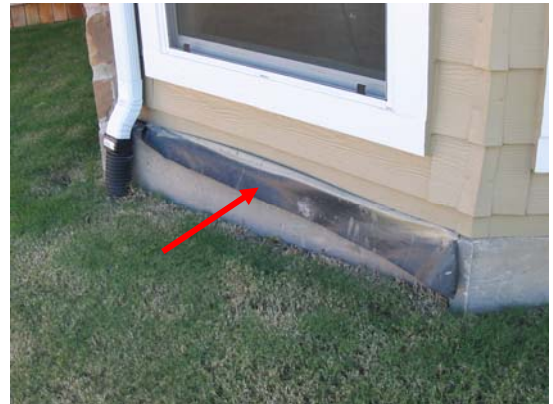
Items in Need of Repair: Foundation

- x Remove plastic at rear patio under siding.
- x Form board left in place on south side of garage.

- x Remove plastic at rear patio under siding.
- x Form board left in place on south side of garage.

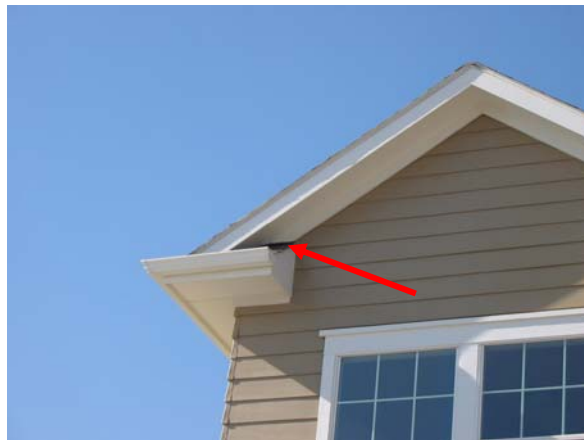
- x Flashing is lifting in the front gable wrap arounds. This should be secured to prevent water penetration.

- x Flashing is lifting in the front gable wrap arounds. This should be secured to prevent water penetration.

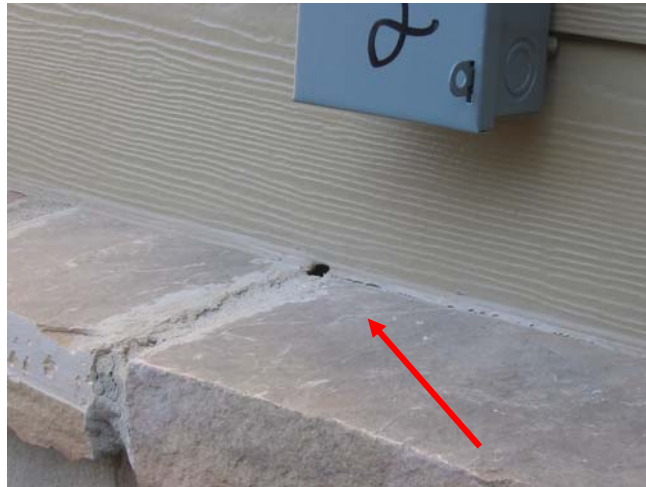
- x Need touch up caulk on east and south sides where siding meets stone.

- x Need touch up caulk on east and south sides where siding meets stone.

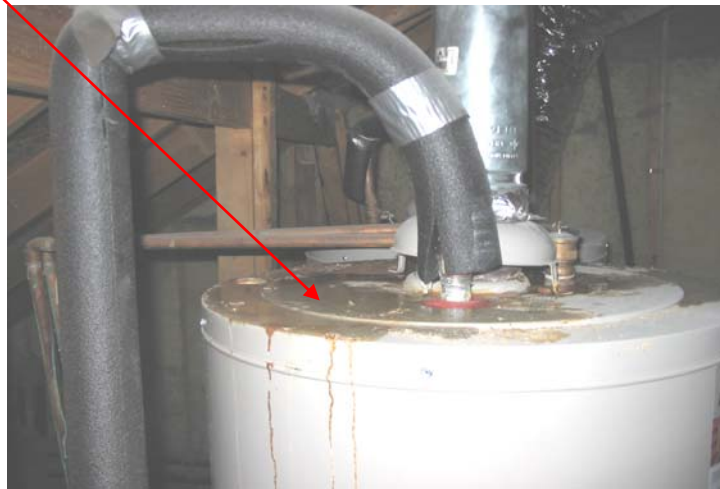
- x There is a leak at the top of the rear water heater.

- x There is a leak at the top of the rear water heater.
